FOUNDATIONS ON EXPANSIVE SOILS

Case VI

AN ANATOMY OF A LAWSUIT

The project is the Colorado State Veterans Nursing Home located at Florence, Colorado. A preliminary geotechnical report was prepared in 1973 for the purpose of determining the most desirable location for construction.

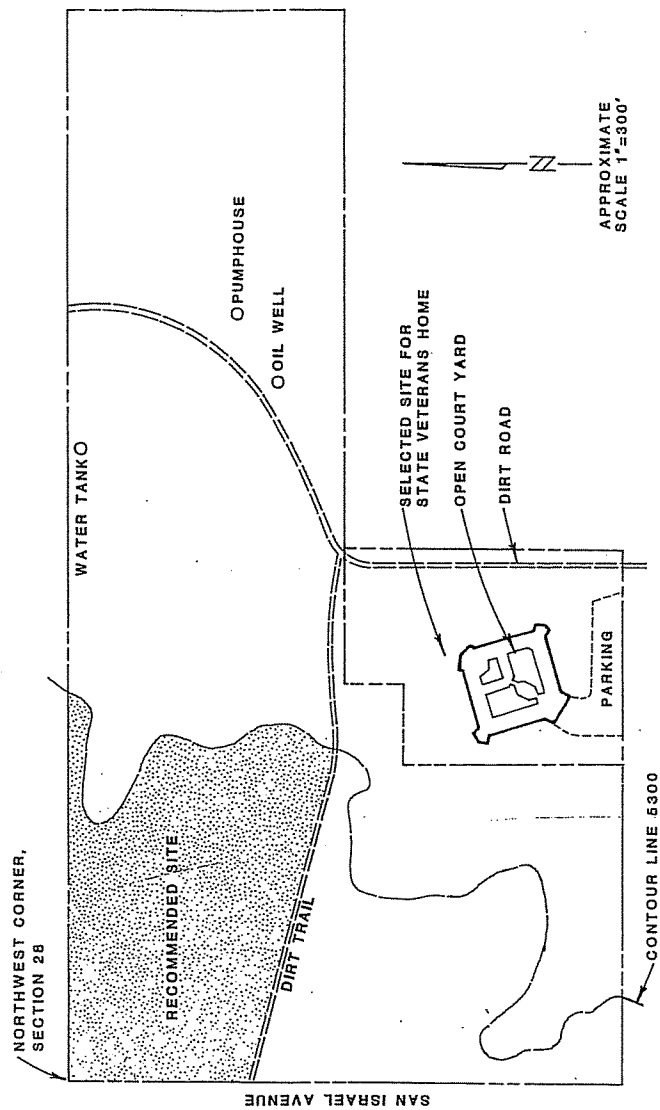
The northwestern portion of the site is located in a broad valley where the bedrock is generally deep, and the upper soils do not possess swell potential. This area (north of the trail and west of contour line 5300) in our opinion appears to be the most desirable location for construction as shown on Figure VI-1. The figure also shows the final selected location of the building.

Figure VI-1. Proposed and final location of State Veterans Home.
