### *The Decision to Launch the Space Shuttle Challenger*

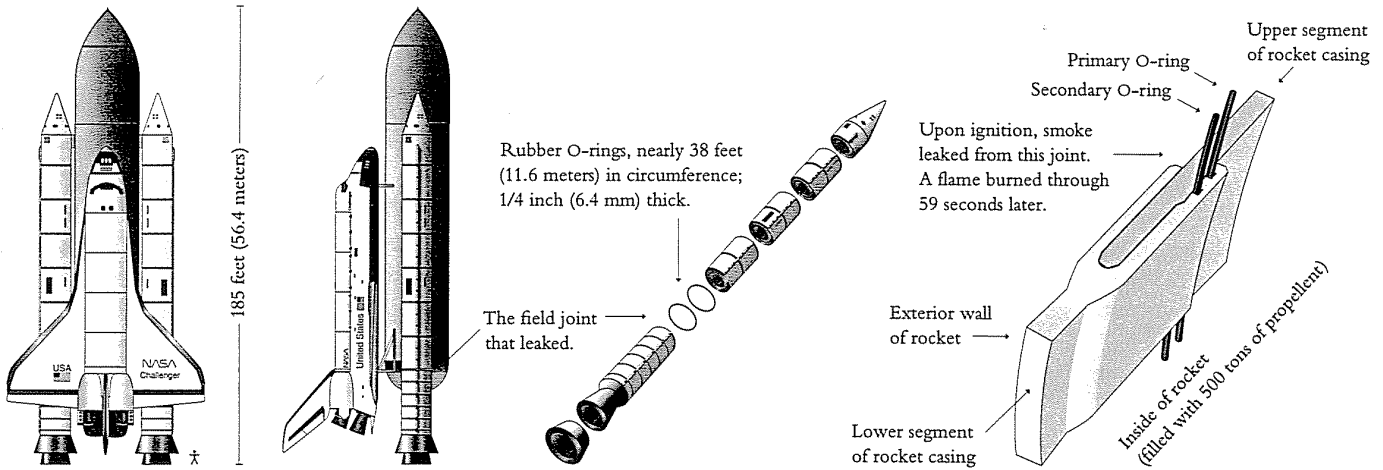
The shuttle consists of an *orbiter* (which carries the crew and has powerful engines in the back), a large liquid-fuel *tank* for the orbiter engines, and 2 solid-fuel *booster rockets* mounted on the sides of the central tank. Segments of the booster rockets are shipped to the launch site, where

they are assembled to make the solid-fuel rockets. Where these segments mate, each joint is sealed by two rubber O-rings as shown above. In the case of the Challenger accident, one of these joints leaked, and a torch-like flame burned through the side of the booster rocket.

THE immediate cause of the accident—an O-ring failure—was quickly obvious (see the photographs at left). But what are the general causes, the lessons of the accident? And what is the meaning of Challenger? Here we encounter diverse and divergent interpretations, as the facts of the accident are reworked into moral narratives.<sup>26</sup> These allegories regularly advance claims for the special relevance of a distinct analytic approach or school of thought: if only the engineers and managers had the skills of field X, the argument implies, this terrible thing would not have happened. Or, further, the insights of X identify the deep causes of the failure. Thus, in management schools, the accident serves as a case study for reflections about groupthink, technical decision-making in the face of political pressure, and bureaucratic failures to communicate. For the authors of engineering textbooks and for the physicist Richard Feynman, the Challenger accident simply confirmed what they already

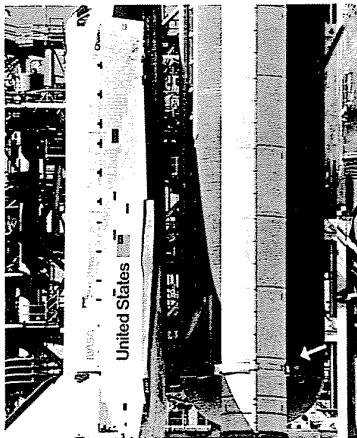
Less than 1 second after ignition, a puff of smoke appeared at the aft joint of the right booster, indicating that the O-rings burned through and failed to seal. At this point, all was lost.

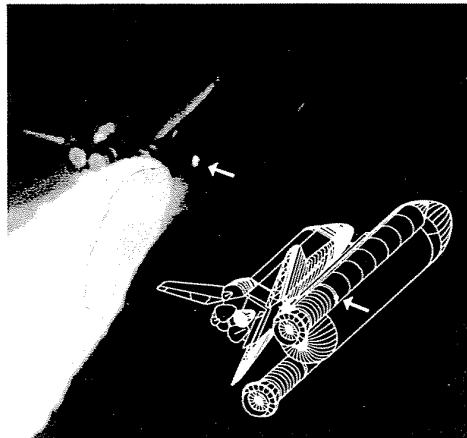
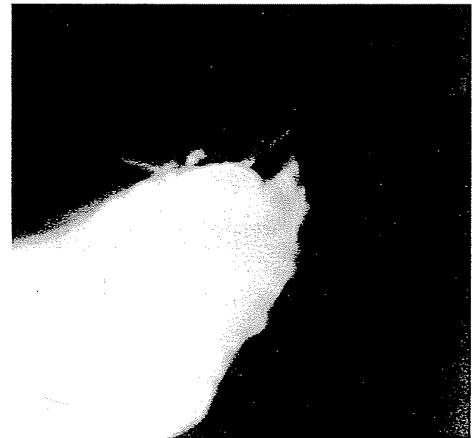
On the launch pad, the leak lasted only about 2 seconds and then apparently was plugged by putty and insulation as the shuttle rose, flying through rather strong cross-winds. Then 58.788 seconds after ignition, when the Challenger was 6 miles up, a flicker of flame emerged from the leaky joint. Within seconds, the flame grew and engulfed the fuel tank (containing liquid hydrogen and liquid oxygen). That tank ruptured and exploded, destroying the shuttle.

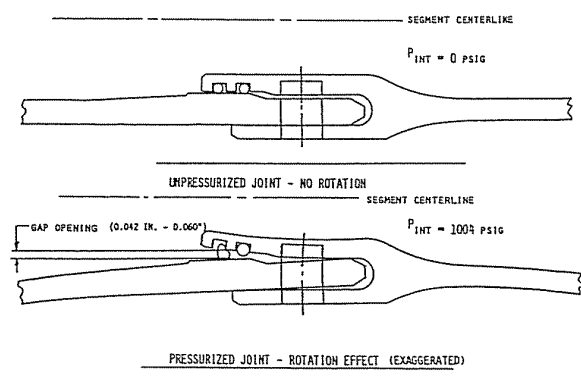
BLOW BY HISTORY	HISTORY OF O-RING TEMPERATURES (DEGREES - F)				
	MOTOR	MBT	AMB	O-RING	WIND
SRM-15 WORST BLOW-BY					
o 2 CASE JOINTS (80°), (110°) ARC	DM-1	68	36	47	10 MPH
o MUCH WORSE VISUALLY THAN SRM-22	DM-2	76	45	52	10 MPH
SRM 22 BLOW-BY	QM-3	72.5	40	48	10 MPH
o 2 CASE JOINTS (30-40°)	QM-4	76	48	51	10 MPH
SRM-13A, 15, 16A, 18, 23A 24A	SRM-15	52	64	53	10 MPH
o NOZZLE BLOW-BY	SRM-22	77	78	75	10 MPH
	SRM-25	55	26	29	10 MPH
				27	25 MPH

Two charts further narrowed the evidence. Above left, "Blow-By History" mentions the two previous launches, SRM 15 and SRM 22, in which soot (blow-by) was detected in the field joints upon post-launch examination. This information, however, was already reported in the more detailed damage table that followed the title chart.<sup>30</sup> The bottom two lines refer to *nozzle* blow-by, an issue not relevant to launching the Challenger in cold weather.<sup>31</sup>

Although not shown in the blow-by chart, temperature is part of the analysis: SRM 15 had substantial O-ring damage and also was the coldest launch to date (at 53° on January 24, 1985, almost one year before the Challenger). This argument by analogy, made by those opposed to launching the Challenger the next morning, is reasonable, relevant, and weak. With only one case as evidence, it is usually quite difficult to make a credible statement about cause and effect.

<sup>30</sup> On the blow-by chart, the numbers 80°, 110°, 30°, and 40° refer to the arc covered by blow-by on the 360° of the field (called here the "case") joint.

If one case isn't enough, why not look at two? And so the parade of anecdotes continued. By linking the blow-by chart (above left) to the temperature chart (above right), those who favored launching the Challenger spotted a weakness in the argument. While it was true that the blow-by on SRM 15 was on a cool day, the blow-by on SRM 22 was on a *warm* day at a temperature of 75° (temperature chart, second column from the right). One engineer said, "We had blow-by on the hottest motor [rocket] and on the coldest motor."<sup>32</sup> The superlative "-est" is an extreme characterization of these thin data, since the total number of launches under consideration here is exactly *two*.

With its focus on blow-by rather than the more common erosion, the chart of blow-by history invited the rhetorically devastating—for those opposed to the launch—comparison of SRM 15 and SRM 22. In fact, as the blow-by chart suggests, the two flights profoundly differed: the 53° launch probably barely survived with significant *erosion* of the primary and secondary O-rings on both rockets as well as blow-by; whereas the 75° launch had no erosion and only blow-by.

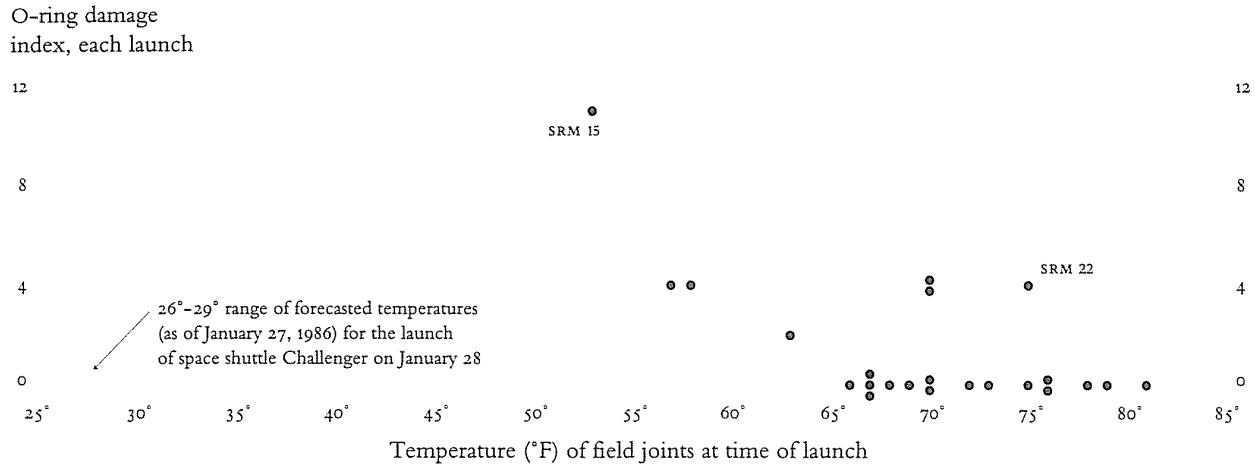
Above, a scatterplot shows the experience of all 24 launches prior to the Challenger. Like the table, the graph reveals the serious risks of a launch at 29°. Over the years, the O-rings had persistent problems at cooler temperatures: indeed, *every* launch below 66° resulted in damaged O-rings; on warmer days, only a few flights had erosion. In this graph, the temperature scale extends down to 29°, visually expressing the stupendous extrapolation beyond all previous experience that must be made in order to launch at 29°. The coolest flight without any O-ring damage was at 66°, some 37° warmer than predicted for the Challenger; the forecast of 29° is 5.7 standard deviations distant from the average temperature for previous launches. This launch was completely outside the engineering database accumulated in 24 previous flights.

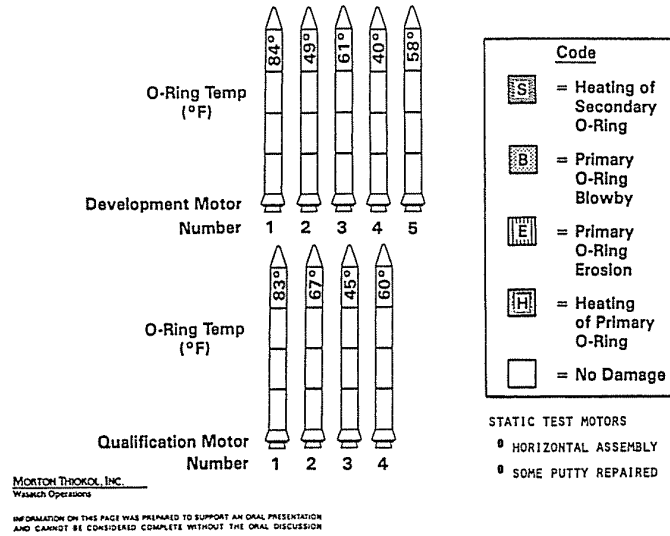
### History of O-Ring Damage in Field Joints

Prepared for testimony to the commission, the chart above shows nine little rockets annotated with temperature readings turned sideways. A legend shows a damage scale. Apparently measured in orderly steps, this scale starts with the most serious problem ("Heating of Secondary O-ring," which means a primary ring burned through and leaked) and then continues in several ordered steps to "No Damage." Regrettably, the scale's visual representation is disordered: the cross-hatching varies erratically from dark, to light, to medium dark, to darker, to lightest—a visual pattern unrelated to the substantive order of the measured scale. A letter-code accompanies the cross-hatching. Such codes can hinder visual understanding.

At any rate, these nine rockets suffered no damage, even at quite cool temperatures. But the graph is not on point, for it is based on test data from "Development and Qualification Motors"—all fixed rockets ignited on horizontal test stands at Thiokol, never undergoing the stress of a real flight. Thus this evidence, although perhaps better than nothing (that's all it is better than), is not directly relevant to evaluating the dangers of a cold-weather launch. Some of these same temperature numbers for test rockets are found in a pre-launch chart that we saw earlier.

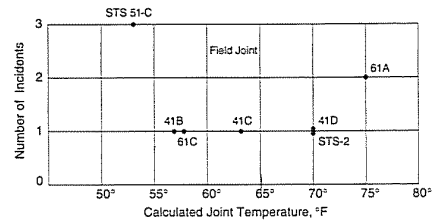
<sup>39</sup> Most accounts of the Challenger reproduce a scatterplot that apparently demonstrates the analytical failure of the pre-launch debate. This graph depicts only launches with O-ring damage and their temperatures, omitting all damage-free launches (an absence of data points on the line of zero incidents of damage):

First published in the shuttle commission report (PCSSCA, volume I, p. 146), the chart is a favorite of statistics teachers. It appears in textbooks on engineering, graphics, and statistics—relying on Dalal, Fowlkes, Hoadley, "Risk Analysis of the Space Shuttle: Pre-Challenger Prediction of Failure," who describe the scatterplot as having a central role in the launch decision. (The commission report does not say when the plot was made.) The graph of the missing data-points is a vivid and poignant object lesson in how not to look at data when making an important decision. But it is too good to be true! First, the graph was *not* part of the pre-launch debate; it was *not* among the 13 charts used by Thiokol and NASA in deciding to launch. Rather, it was drawn *after* the accident by two staff members (the executive director and a lawyer) at the commission *as their simulation* of the poor reasoning in the pre-launch debate. Second, the graph implies that the pre-launch analysis examined 7 launches at 7 temperatures with 7 damage measurements. That is not true; only 2 cases of blow-by and 2 temperatures were linked up. The actual pre-launch analysis was much thinner than indicated by the commission scatterplot. Third, the damage scale is dequantified, only counting the number of incidents rather than measuring their severity. In short, whether for teaching statistics or for seeking to understand the practice of data graphics, why use an inaccurately simulated post-launch chart when we have the genuine 13 pre-launch decision charts right in hand? (On this scatterplot, see Lighthall, "Launching the Space Shuttle Challenger;" and Vaughan, *Challenger Launch Decision*, pp. 382–384.)

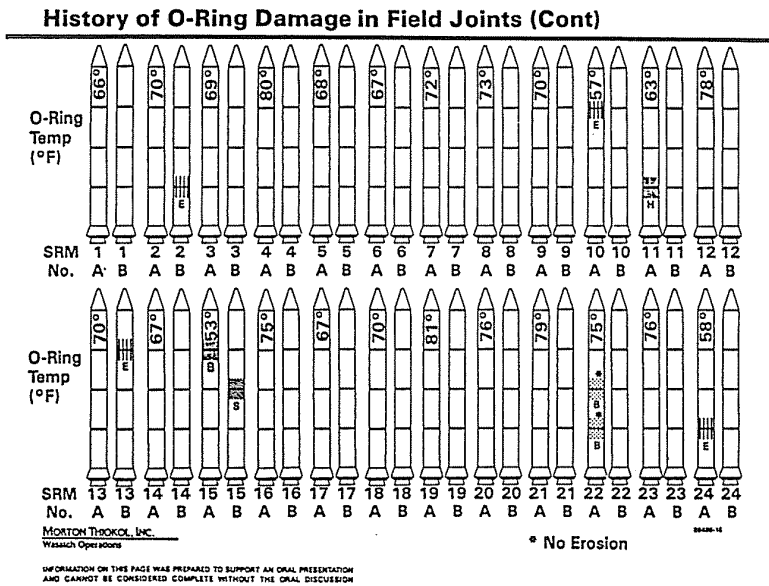
The second chart in the sequence is most significant. Shown below are the O-ring experiences of all 24 previous shuttle launches, with 48 little rockets representing the 24 flight-pairs:

Rockets marked with the damage code show the seven flights with O-ring problems. Launch temperature is given for each pair of rockets. Like the data matrix we saw earlier, this display contains *all* the information necessary to diagnose the relationship between temperature and damage, if we could only see it.<sup>41</sup> The poor design makes it impossible to learn what was going on. In particular:

<sup>41</sup> This chart shows the rocket pair SRM 4A, SRM 4B at 80°F, as having *undamaged* O-rings. In fact, those rocket casings were lost at sea and their O-ring history is unknown.

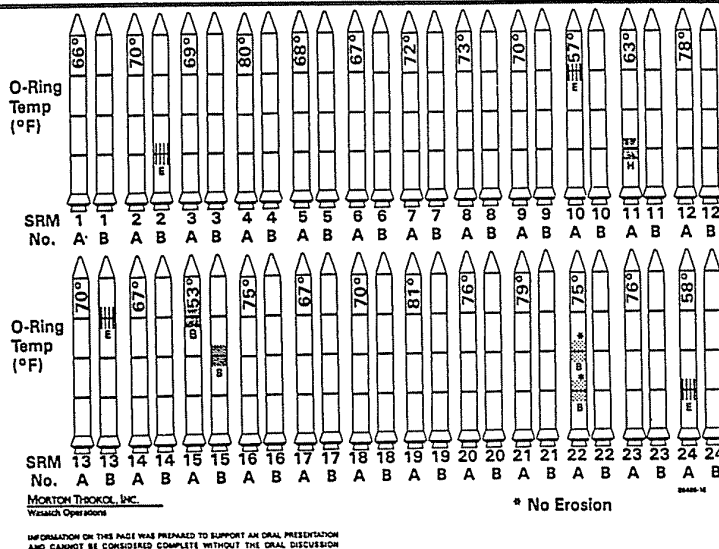
## History of O-Ring Damage in Field Joints (Cont)

*Chartjunk* Good design brings *absolute attention* to data. Yet instead of focusing on a possible link between damage and temperature—the vital issue here—the strongest visual presence in this graph is the clutter generated by the outlines of the 48 little rockets. The visual elements bounce and glow, as heavy lines activate the white space, producing visual noise. Such misplaced priorities in the design of graphs and charts should make us suspicious about the competence and integrity of the analysis. Chartjunk indicates statistical stupidity, just as weak writing often reflects weak thought: “Neither can his mind be thought to be in tune, whose words do jarre,” wrote Ben Jonson in the early 1600s, “nor his reason in frame, whose sentence is preposterous.”<sup>42</sup>

*Lack of Clarity in Depicting Cause and Effect* Turning the temperature numbers sideways obscures the causal variable. Sloppy typography also impedes inspection of these data, as numbers brush up against line-art. Likewise garbled is the measure of effect: O-ring anomalies are depicted by little marks—scattered and opaquely encoded—rather than being totaled up into a summary score of damage for each flight. Once again Jonson’s Principle: these problems are more than just poor design, for a lack of visual clarity in arranging evidence is a sign of a lack of intellectual clarity in reasoning about evidence.

*Wrong Order* The fatal flaw is the *ordering* of the data. Shown as a time-series, the rockets are sequenced by date of launching—from the first pair at upper left SRM 1 1 to the last pair at lower right 24 24 (the launch immediately prior to Challenger). The sequential order conceals the possible link between temperature and O-ring damage, thereby throwing statistical thinking into disarray. The time-series

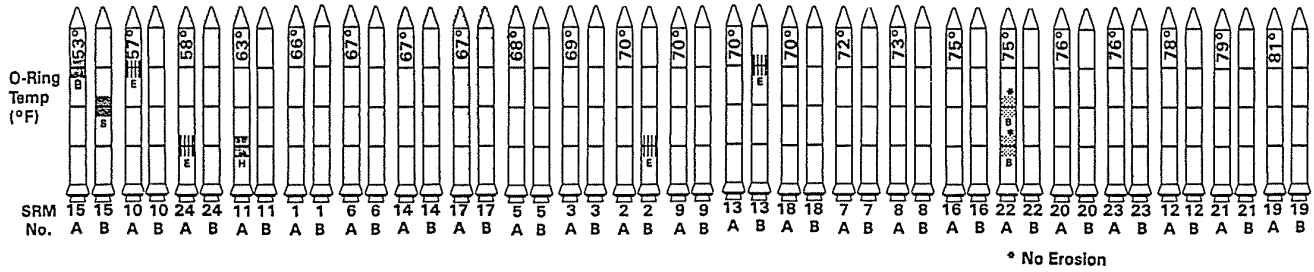
Information displays should serve the analytic purpose at hand; if the substantive matter is a possible cause-effect relationship, then graphs should organize data so as to illuminate such a link. Not a complicated idea, but a profound one. Thus the little rockets must be *placed in order by temperature, the possible cause*. Above, the rockets are so ordered by temperature. This clearly shows the serious risks of a cold launch, for most O-ring damage occurs at cooler temperatures. Given this evidence, how could the Challenger be launched at 29°?

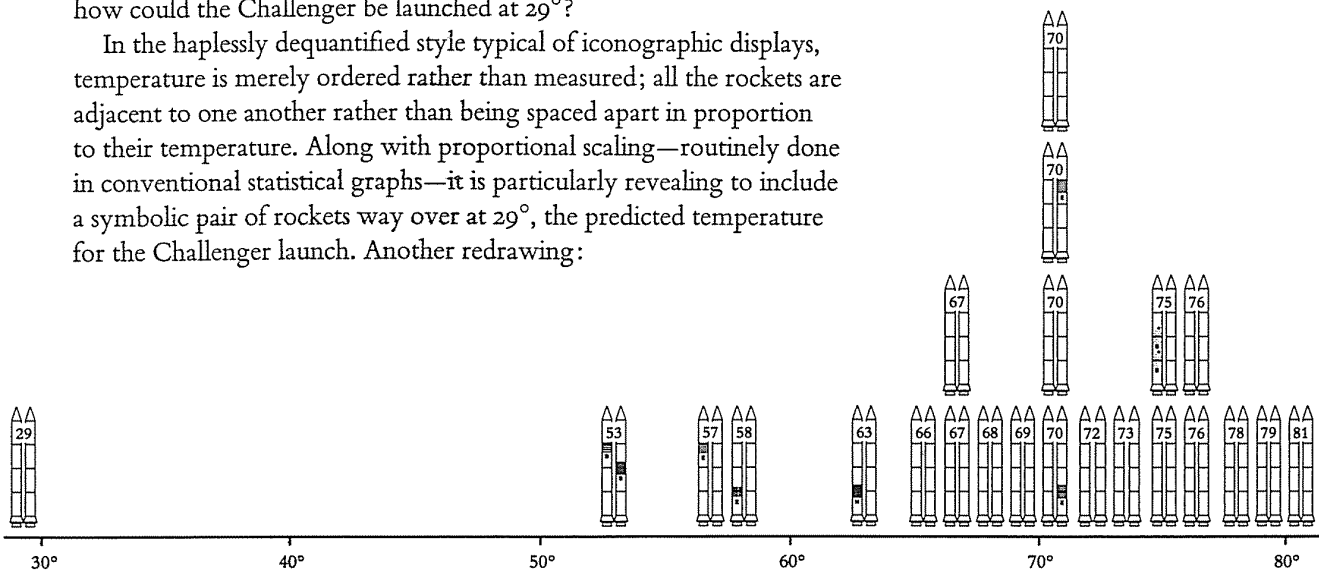
In the haplessly dequantified style typical of iconographic displays, temperature is merely ordered rather than measured; all the rockets are adjacent to one another rather than being spaced apart in proportion to their temperature. Along with proportional scaling—routinely done in conventional statistical graphs—it is particularly revealing to include a symbolic pair of rockets way over at 29°, the predicted temperature for the Challenger launch. Another redrawing:

Even after repairs, the pictorial approach with cute little rockets remains ludicrous and corrupt. The excessively original artwork just plays around with the information. It is best to forget about designs involving such icons and symbols—in this case and, for that matter, in nearly all other cases. These data require only a simple scatterplot or an ordered table to reveal the deadly relationship.

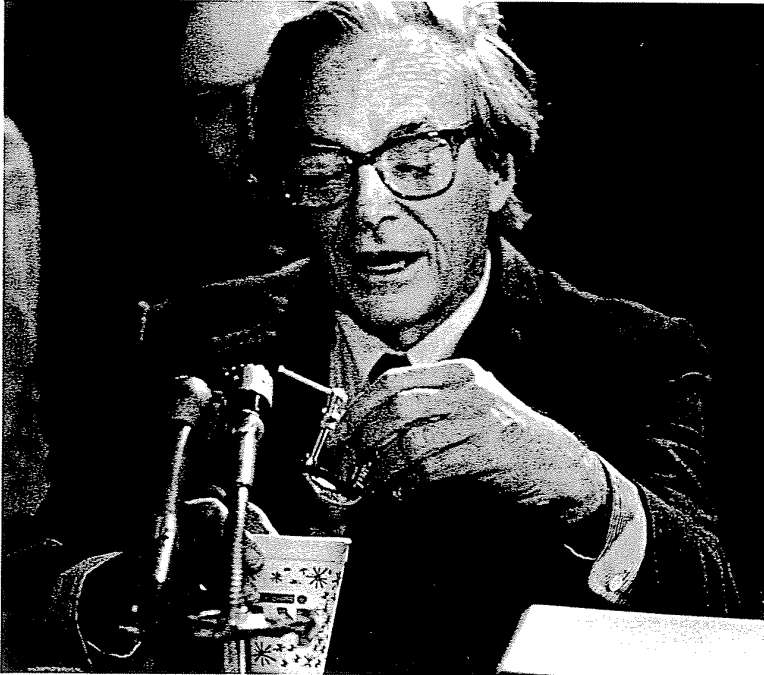
At a meeting of the commission investigating the shuttle accident, the physicist Richard Feynman conducted a celebrated demonstration that clarified the link between cold temperature and loss of resiliency in the rubber O-rings. Although this link was obvious for weeks to engineers and those investigating the accident, various officials had camouflaged the issue by testifying to the commission in an obscurantist language of evasive technical jargon.<sup>43</sup> Preparing for the moment during the public hearing when a piece of an O-ring (from a model of the field joint) would be passed around, Feynman had earlier that morning purchased a small clamp at a hardware store in Washington. A colorful theater of physics resulted. Feynman later described his famous experiment:

I take the clamp out, hold it in the air, and loosen it as I talk: "I discovered that when you undo the clamp, the rubber doesn't spring back. In other words, for more than a few seconds, there is no resilience in this particular material when it is at a temperature of 32 degrees. I believe that has some significance for our problem."<sup>44</sup>

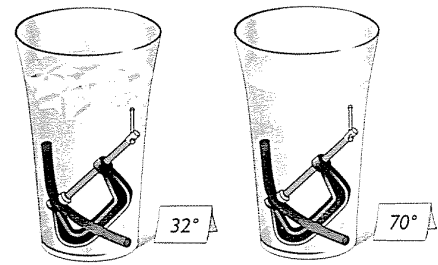
<sup>48</sup> Feynman was aware of the problematic experimental design. During hearings in the afternoon following the ice-water demonstration, he began his questioning of NASA management with this comment: "We spoke this morning about the resiliency of the seal, and if the material weren't resilient, it wouldn't work in the appropriate mode, or it would be less satisfactory, in fact, it might not work well. I did a little experiment here, and *this is not the way to do such experiments*, indicating that the stuff looked as if it was less resilient at lower temperatures, in ice." (PCSSCA, volume iv, pp. 739-740, transcript, emphasis added.) Drawing of two-glass experiment by Weilin Wu and Edward Tufte.
