CASE STUDY 7.1

Classic Case: de Havilland's Falling Comet

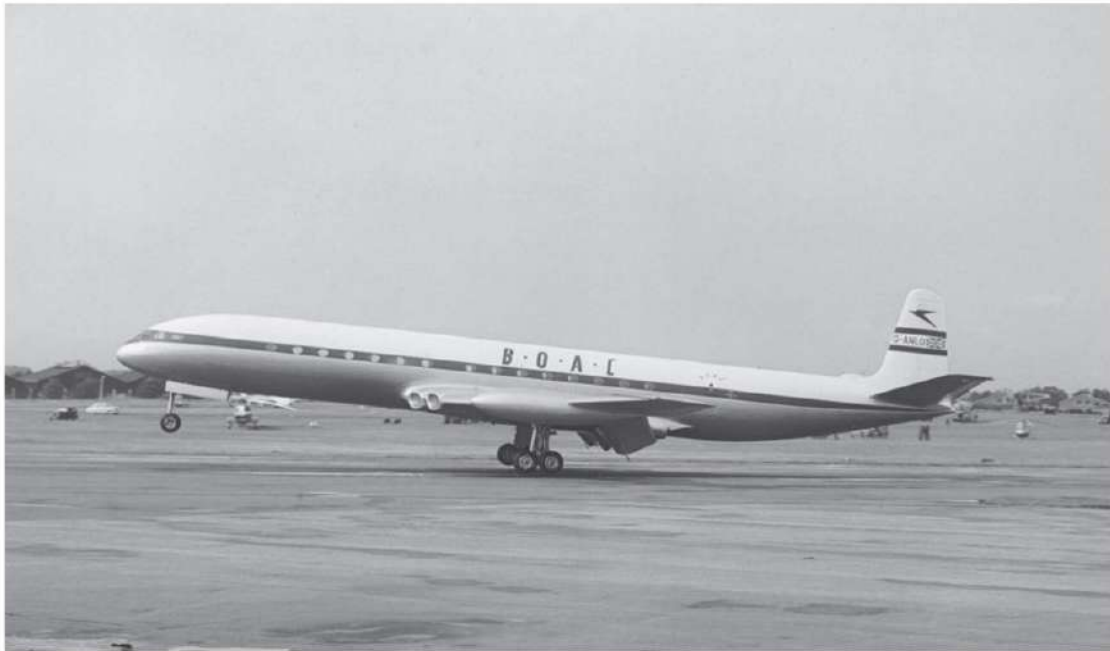
FIGURE 7.10 The de Havilland Comet

De Havilland engineers sought to create a streamlined airplane that could simultaneously carry up to 50 passengers in comfort, while maintaining aerodynamics and high speed. After working with several design alternatives, the Comet began to take shape. Its design was indeed distinctive: the four jet engines were embedded in pairs in the wing roots, at the point where they joined the fuselage. From the front, the aircraft looked as though its wings were held in place by the engines.

The result of these innovative engineering designs was an aircraft that had remarkable stability in flight, was sleek in appearance, and was very fast.
